CASE STUDY

Hagley Road

54, Hagley Road

Grade A high rise office building located in central Birmingham

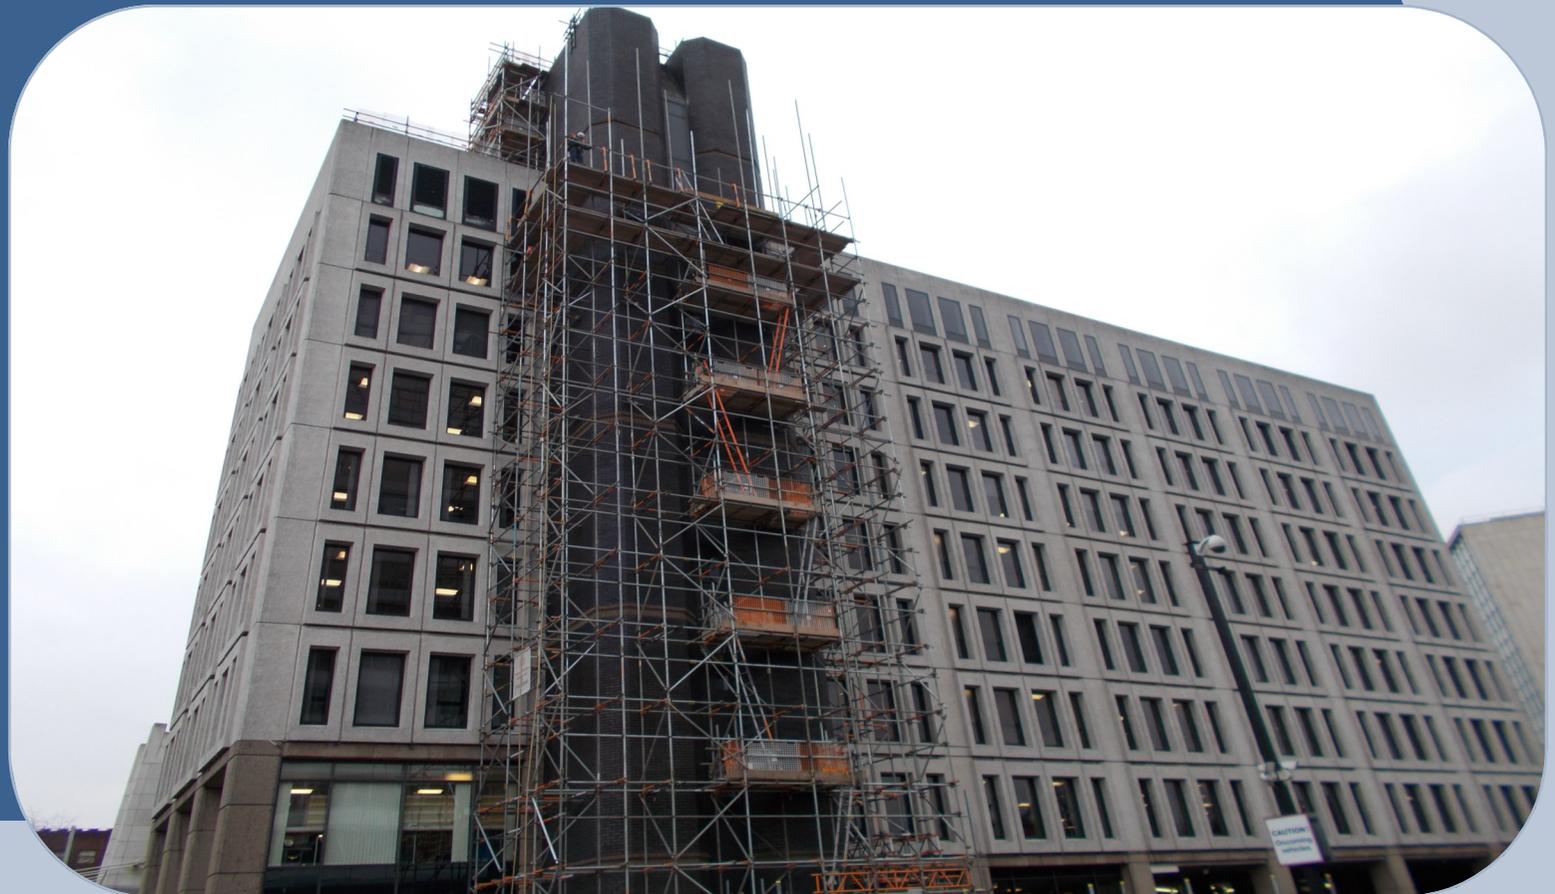
The building was in need of repairs due to water ingress and structural damage at roof level

The flat roof had a number of damages that were identified and a Decothane liquid applied membrane was deemed to be the optimal solution.

Following repair work and preparation of the surface by our roofing team, a total of 540 m² of the waterproofing system was laid to ensure that all further damp ingress into the building was prevented.

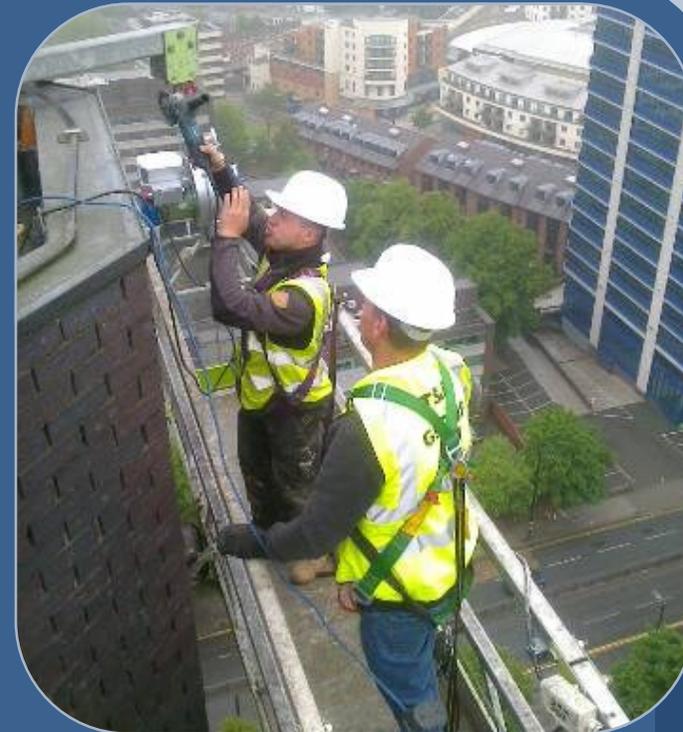
To the east elevation, structural damage to the brickwork was identified and remedied by our leading edge trained repair crew using a specialist access cradle.

- 36m High level scaffold install to west wing
- East wing specialist cradle
- 540m² Decothane waterproof coating
- Structural defect repairs
